**KOMITE NASIONAL KESELAMATAN TRANSPORTASI
REPUBLIC OF INDONESIA**

KNKT.18.10.35.04

Aircraft Accident Investigation Report

**PT. Lion Mentari Airlines
Boeing 737-8 (MAX); PK-LQP
Tanjung Karawang, West Java
Republic of Indonesia
29 October 2018**

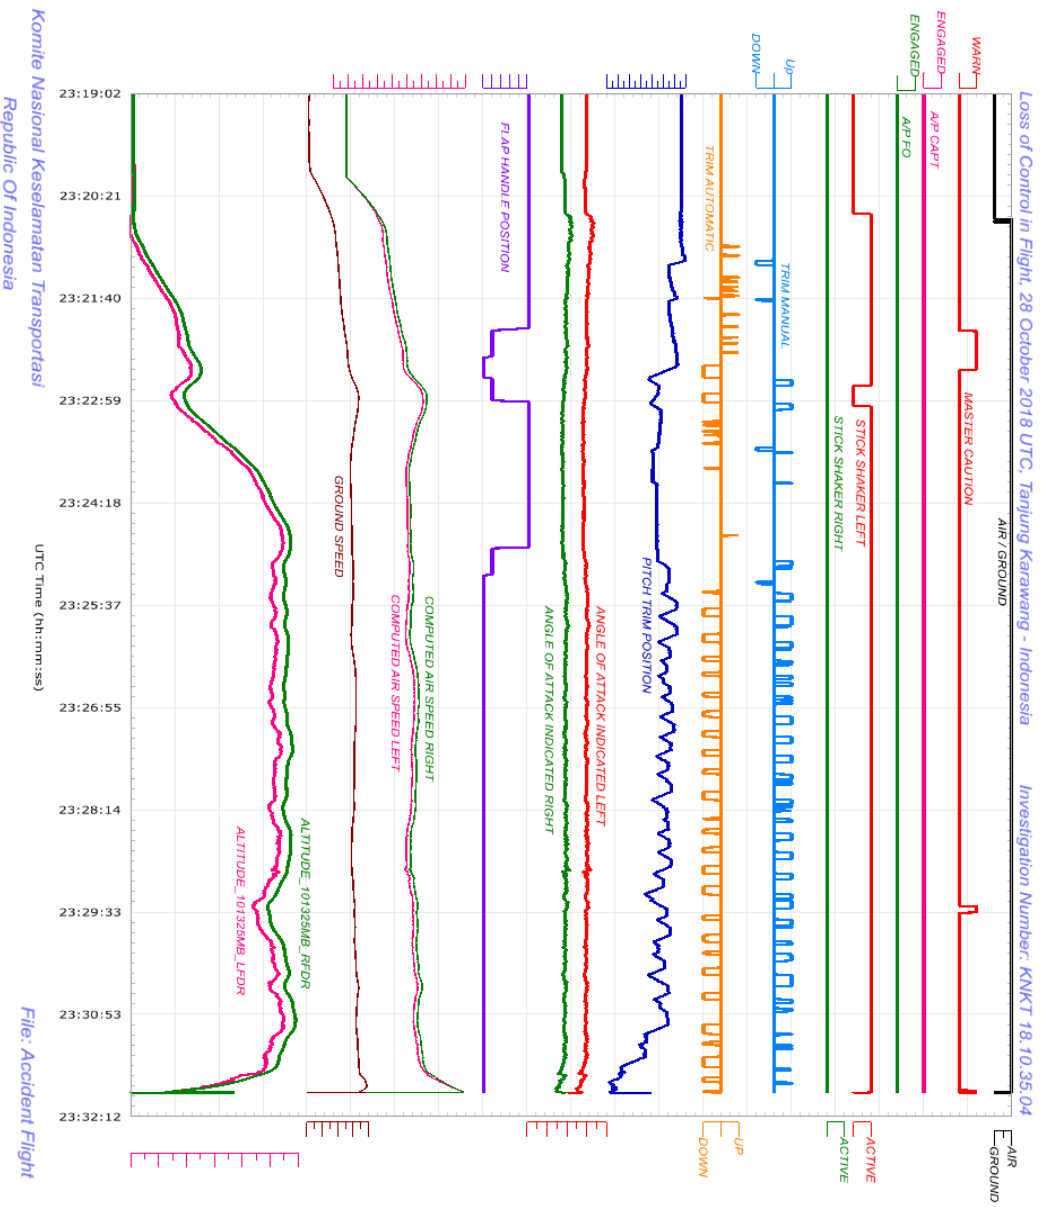
Figure 5: The significant parameters from the accident flight

Several significant parameters of the DFDR are shown on the following figures.

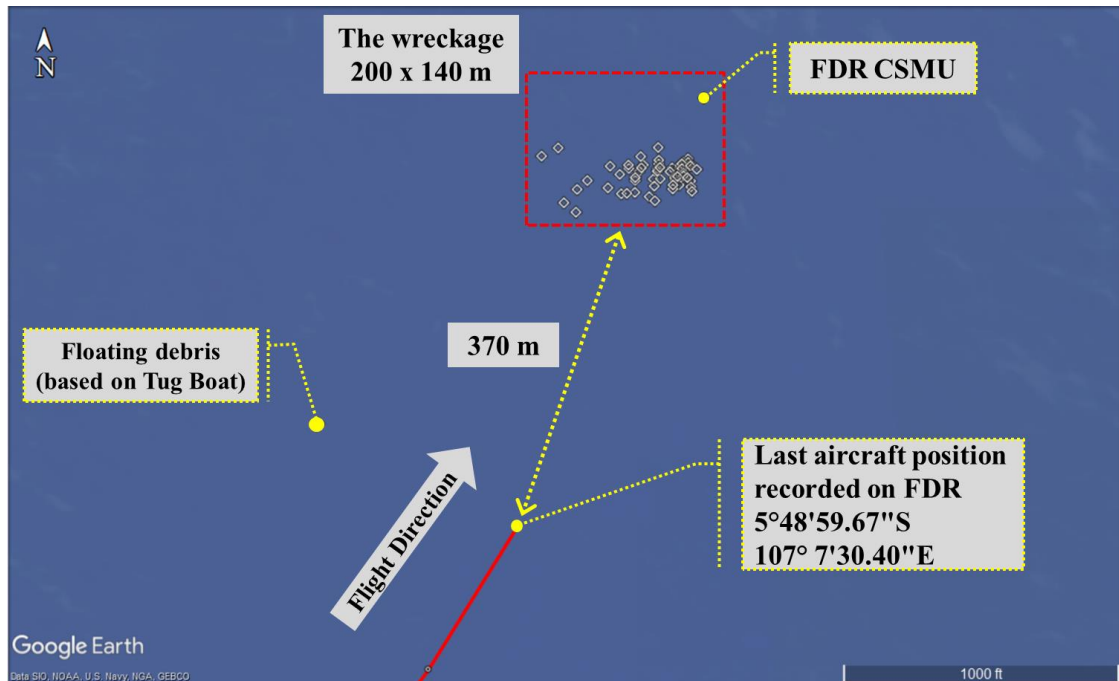
Figure 8: The wreckage distribution

The CSMU was found at 5°48'43.20"S 107°7'37.60"E which was within the wreckage distribution area. Several parts of the aircraft were recovered and transported to Jakarta International Container Terminal (JICT). The wreckage recovered was from all parts of the aircraft from the forward part to the aft part.

The recovered wreckage identified consisted of, but not limited to, the left and right engines, both main landing gears, parts of the empennage, parts of the forward and aft left passenger doors, parts of the wings, a flight crew oxygen bottle, and parts of a circuit breaker panel.

The damage to the aircraft suggested a high energy impact.
