**KOMITE NASIONAL KESELAMATAN TRANSPORTASI
REPUBLIC OF INDONESIA**

KNKT.18.10.35.04

Aircraft Accident Investigation Report

**PT. Lion Mentari Airlines
Boeing 737-8 (MAX); PK-LQP
Tanjung Karawang, West Java
Republic of Indonesia
29 October 2018**

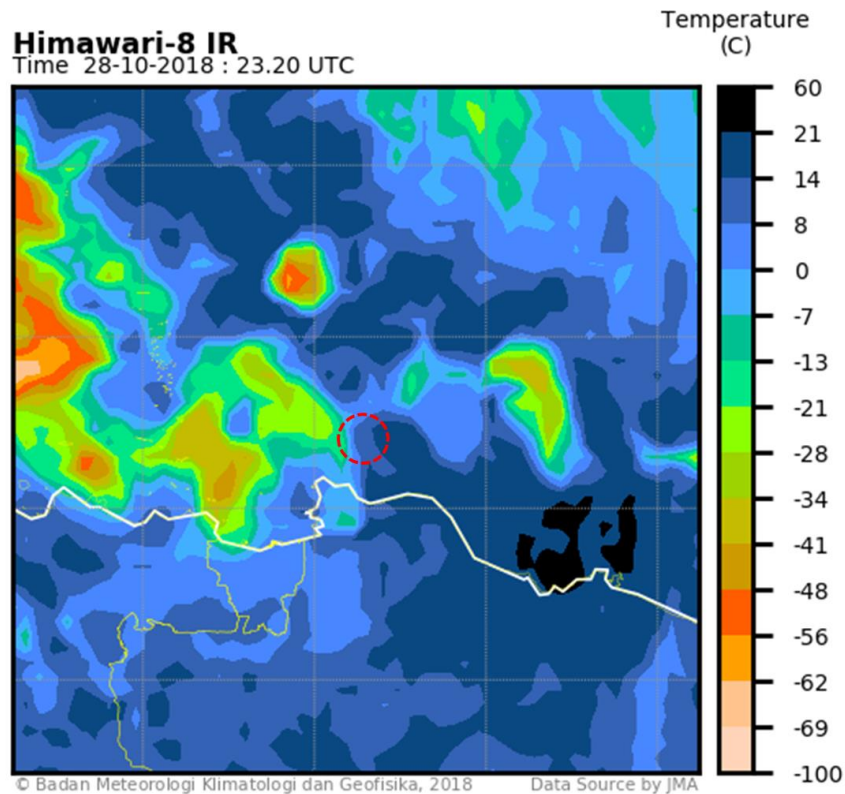
The *Badan Meteorologi Klimatologi dan Geofisika* (BMKG – Bureau of Meteorology, Climatology and Geophysics) provided enhanced infrared satellite images. The enhanced infrared satellite images at 2320 UTC (0620 LT) up to 2330 UTC (0630 LT) indicated that the temperature at the accident site (red circle) was from 0 up to 8°C.

Figure 1: Enhanced infrared satellite image at 2320 UTC (0620 LT)

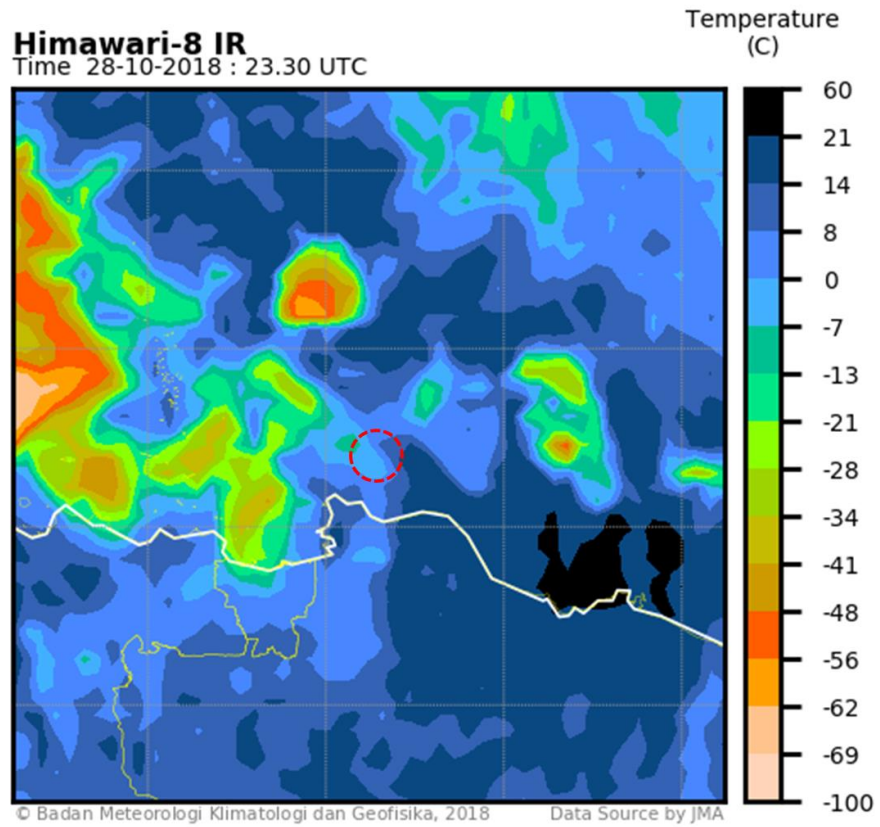
Figure 2: Enhanced infrared satellite image at 2330 UTC (0630 LT)

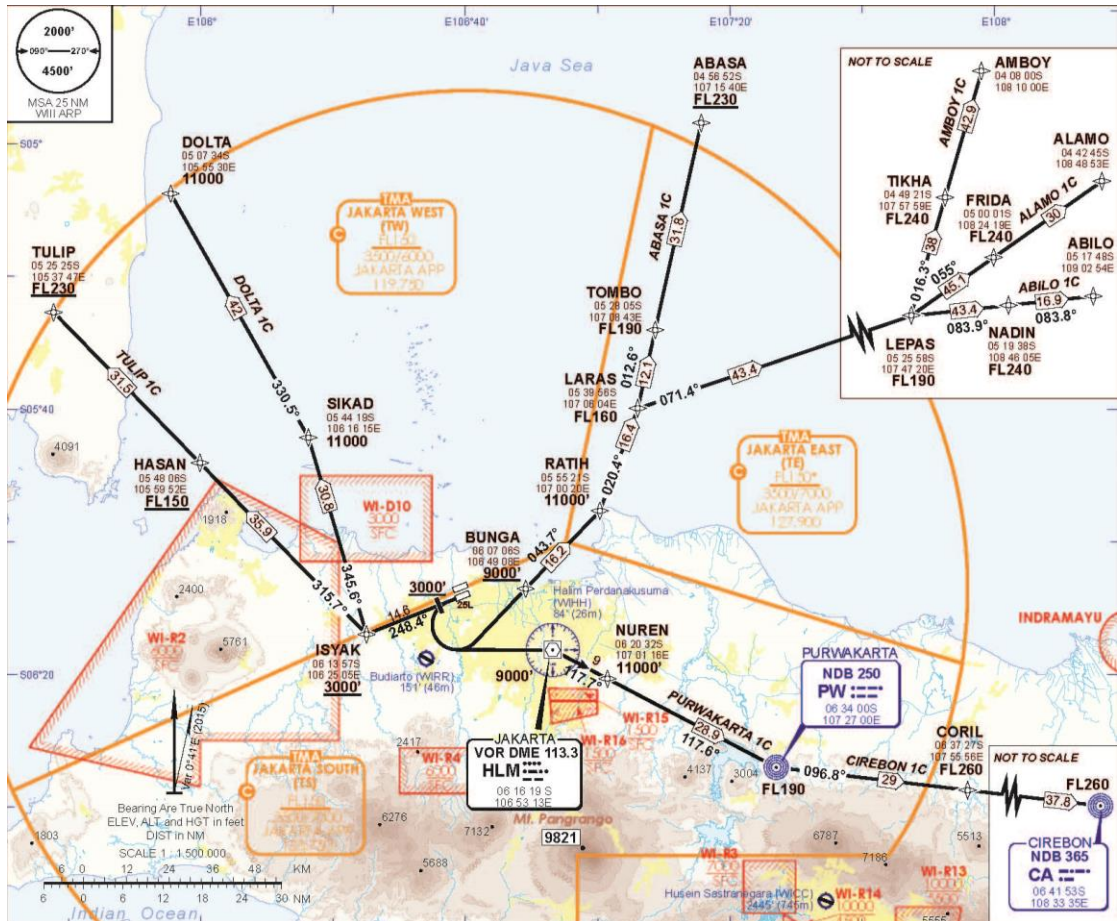
The runway 25L utilized RNAV-1 Standard Instrument Departure (SID), one of the SID was ABASA 1C which is after departure the pilot has to climb on heading 248.4°, at or above 3,000 feet then turn left direct to BUNGA – RATIH – LARAS – TOMBO – ABASA (figure 3).

Figure 3: The RNAV-1 runway 25L (extract from AIP Volume II)

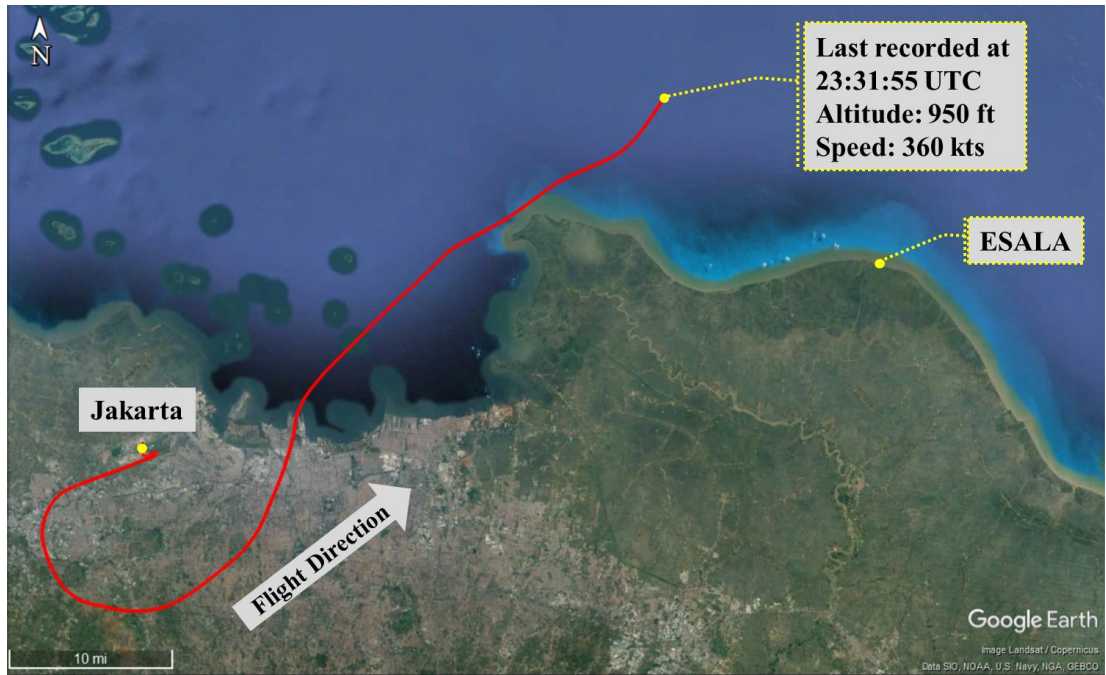
The flight track of the LNI610 based on the ADS-B data superimposed on Google Earth.

Figure 4: The flight track of LNI610 based on ADS-B
